TECHNICAL REPORT GL-88 6

# GEOPHYSICAL INVESTIGATION IN SUPPORT OF BEAVER DAM COMPREHENSIVE SEEPAGE INVESTIGATION

Jose L. Llopis, Dwain K. Butler

May 1988 Final Report

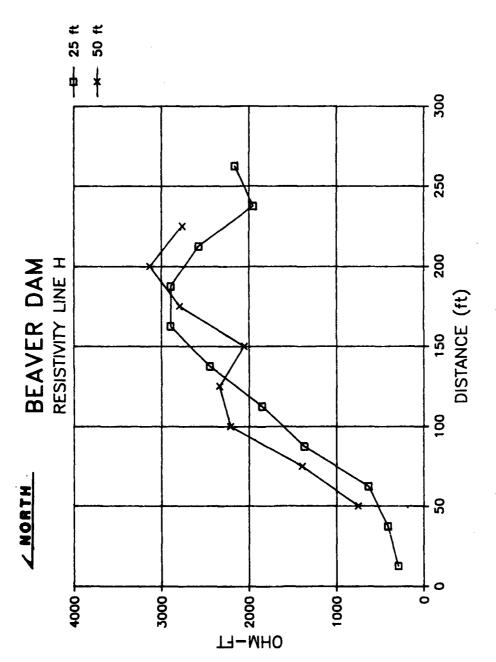
Figure 19. Wenner resistivity profile line H, downstream - Left Abutment Dike 1

- 50. Wenner resistivity profile line H was run downstream of the left abutment of Dike 1 as shown in Figure 10. A-spacings of 25 and 50 ft were used for this profile line. The purpose for conducting this line was to try to project the location of the fault zone downstream. The results of line C are presented in Figure 19. Referring to Figure 19 it can be seen that resistivity values increase to the south and reach a peak value of approximately 3,000 ohm-ft at approximate station 61+40. This high resistivity anomaly may be caused by the fault zone or by resistive rock very close to the surface; however, the location of the high resistivity anomaly is appropriate for a straight line extension of the fault zone.

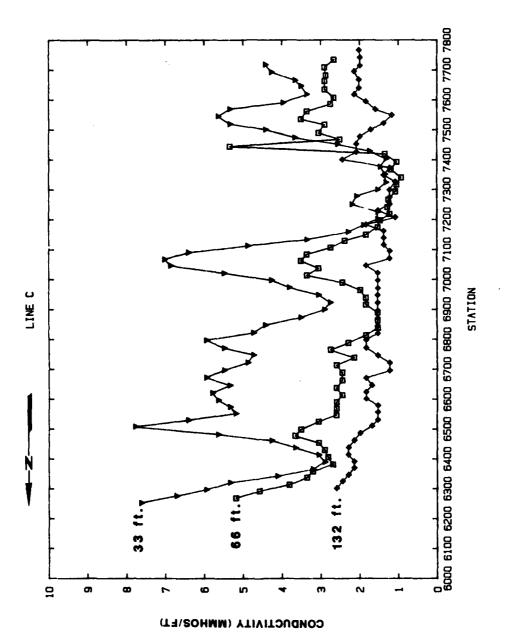
Figure 21. EM profile line C, downstream berm Dike 1

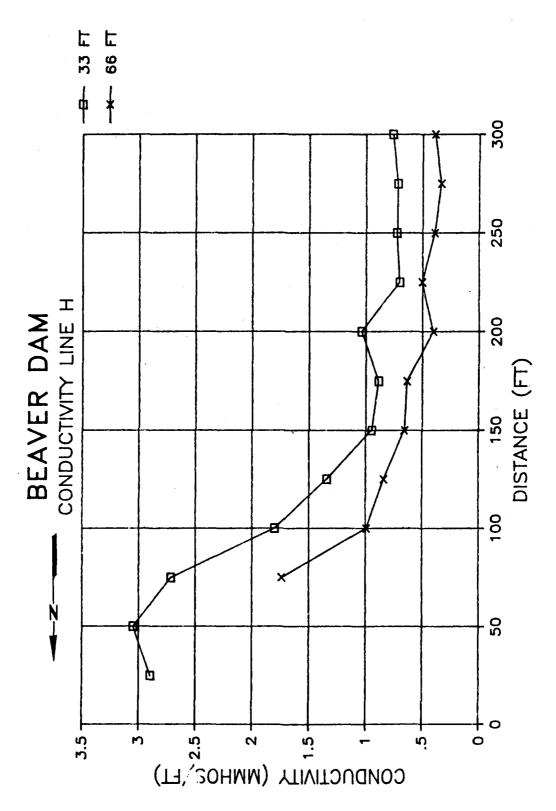
Figure 22. EM profile line H, downstream - Left Abutment Dike 1

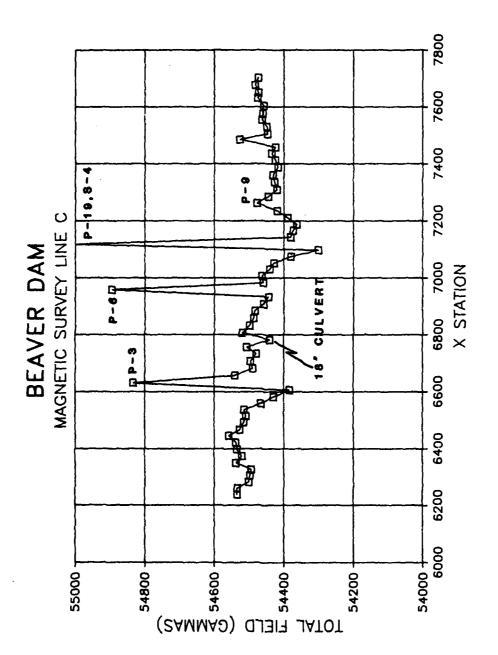
Figure 25. Magnetic survey line C, downstream berm Dike 1

- 55. Magnetic survey line C was run along the downstream berm of Dike 1 as shown in Figure 15. The results are presented in Figure 25. The baseline reading for this survey line is on the order of 54,500 gammas. The spiked features that appear on this survey line and noted in the figure are due to metal piezometer riser pipes in the vicinity of the reading station. No structural features were discerned from line C.

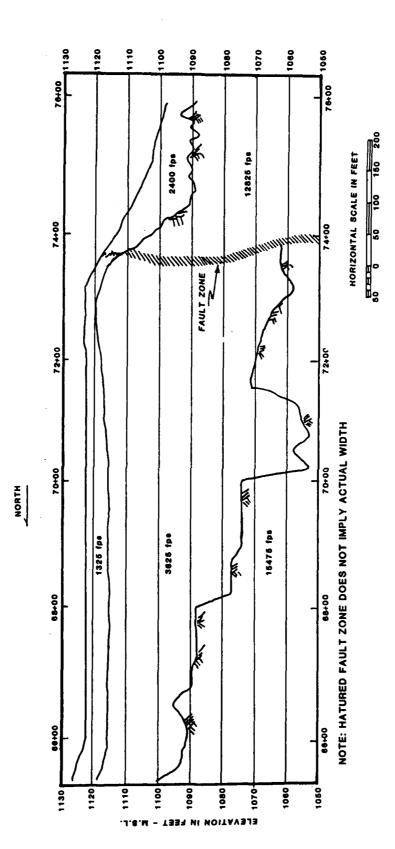
Figure 31. P-wave velocity cross section for Dike 1

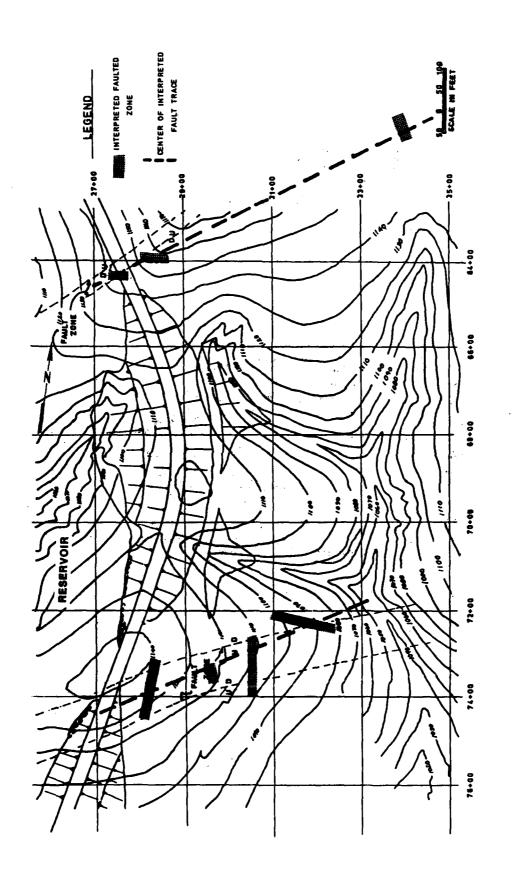
Figure 32. Fault zone locations interpreted from results of geophysical testing

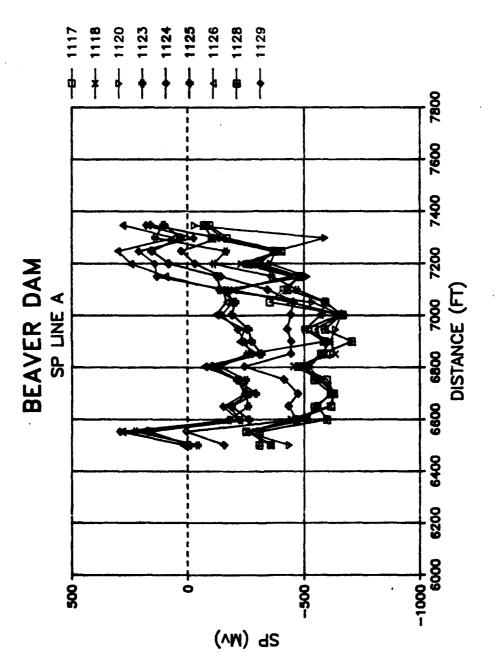
Figure 33. Unprocessed SP readings for SP line A, upstream Dike l

(underwater array) as shown in Figure 7. Figure 33 shows the unprocessed SP readings versus station for various pool elevations. The SP values for a particular pool level were the result of averaging the SP values obtained throughout the year for that particular pool level. Referring to Figure 33 it can be seen that the same general trend in the data exists for each pool level; however, the lines are shifted with respect to each other, i.e., the reference or base line level seems to have changed. Possible causes for these shifts in the data may be due to (1) changes in reference potential of the reference electrode, (2) changes in flow conditions, related to pool level. over broad zones which affect entire SP lines, (3) changes in soil moisture and/or temperature which affect the rod/soil electrochemical potential along the survey lines, and (4) possibly other factors which at this time are not fully understood, such as biological activity, elevation, and soil type (Ernstson and Scherer, 1986). In order to analyze and make meaningful comparisons between the SP values for the various pool levels it was necessary to minimize the time-induced effects which cause a relative shifting of the data. This was accomplished by computing the mean value for each SP data set corresponding to a particular pool elevation and subtracting the mean from each reading for that same line. Figure 34 shows the results of this process on the SP data collected for line A. At this point in the processing stage one can begin searching for anomalous SP readings. In this report anomalous values will be arbitrarily defined as any values greater than +100 mV or less than -100 mV. Using this definition and referring to Figure 34 one can define an anomalous negative SP zone between stations 66+00 and 71+00. Relative positive anomalies are indicated at stations 65+00 and between stations 72+00 and 73+50. Therefore, it would appear that seepage is occurring roughly between stations 66+00 and 71+00. In an attempt to correlate the effects of pool level on SP values the data were further processed, by subtracting SP values obtained for the various pool levels from a reference set of SP readings, in this case the 1,117 ft pool level data. The purpose of this processing was to determine if there existed areas along the profile line where SP values responded to pool level differences. Figure 35 presents the results of the change in SP values relative to the reference low pool elevation, 1,117 ft, for line A (difference plot). In this type of plot, it is assumed that any relatively constant factors which affect each data set in the same way will

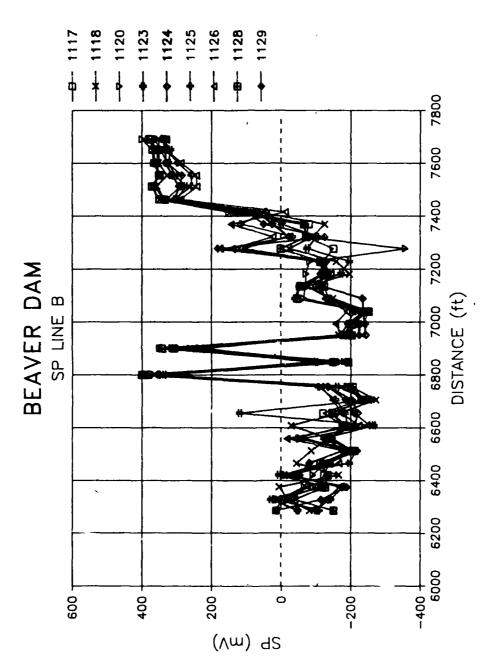
Figure 36. Static SP profile, SP line B, crest Dike l

- 62. Figures 36 and 37 present the SP data obtained along the crest of Dike 1, line B, as shown in Figure 7. Referring to Figure 36 it can be seen that negative SP values exist roughly between stations 63+00 and 73+00 with exceptions occurring at 68+00 and 69+00. No explanation can be given for these two recurring positive peaks. Positive anomalies are also seen between Stations 74+50 and 77+00. It is believed that these positive anomalies may be due to a change in bedrock type which may affect the hydrologic conditions in the vicinity and thus SP values. Figure 37 is the difference plot for line B. SP readings can be seen to be greatly affected by changes in pool elevation across the entire line however, this effect is most prominent between Stations 72+50 and 73+50. Note that the two peaks present in Figure 36 are not present in Figure 37.

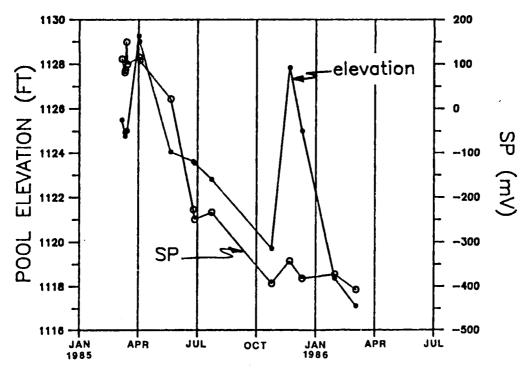
Figure 45. SP versus pool elevation, SP versus time, and pool elevation versus time, for SP line B, crest of Dike 1

- 66. Figures 44 through 48 present plots of SP values versus pool elevation, pool elevation versus time, and SP values versus time for SP lines A through E, respectively. The SP values shown in the plots were obtained by averaging the SP line values recorded for a particular pool elevation. The plots of SP values versus pool elevation would lead one to believe that the higher the pool elevation the higher the average SP readings however, the plots with the SP values and pool elevation plotted versus time indicate that in general as pool elevations decrease SP values also decrease. The exception for this case occurs approximately in the first two months of the study. It is believed that the copper-clad SP electrodes were achieving chemical equilibrium during this time and therefor were subject to fluctuations and inconsistencies.

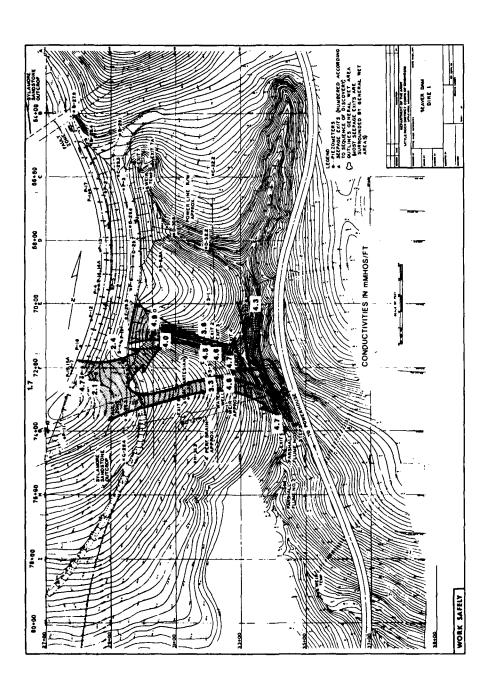
Figure 49. Results of November 1984 downhole water conductivity survey

conductivities and/or temperature could lie along a flow path from a common source. It was felt that these surveys, similar in concept to a dye tracer study, should proceed much more rapidly than a dye tracer study. Figures 49 through 51 present the results obtained from conducting downhole conductivity surveys on three different occasions in accessible piezometers in the vicinity of Dike 1. Figure 49 shows the results obtained on 16 November 1984. The reservoir water conductivity was not obtained on this occasion because the conductivity probe was lost in piezometer P-18. Also, as a result of the loss of the conductivity probe, no conductivity information was obtained for the northern portion of the dike. Measured water conductivities ranged between 1.7 and 5.8 mmhos/ft (resistivities from 588 to 172 ohm-ft). Referring to Figure 49, it can be seen that the water conductivities taken along the south ravine have a mean value of 4.4 mmhos/ft. Other locations with similar readings as those found in the southern ravine area are located at piezometers P-8, Exit 9 (near the Parshall flume), and the water well located at approximate coordinate (72+50,32+25) situated in the south fault zone. These areas with similar conductivities may be hydraulically interconnected. The arrows shown in Figure 49 indicate inferred seepage paths. Figure 50 presents data collected on 14 March 1985. Again, as in the previous set of readings. conductivity readings for seepage exits in the south ravine agree very well with each other. Values for exit 6 (new wet area) and the water well located in the southern fault zone (72+60,32+30) indicate similar values as those in the seepage exits in the south ravine. The arrows shown in Figure 50 indicate probable seepage paths as interpreted from conductivity data collected on 14 March 1985. Finally, Figure 51 presents the results of the downhole conductivity survey conducted on 29 and 30 January 1986. As in the previous surveys, values for the seepage exits agree very well with each other and with values for exit 6. This set of readings included values from recently installed Diezometers. In Figure 51, inferred seepage paths are shown by arrows. Seepage appears to be occurring under the dike in the vicinity of Station 70+00 to 72+00 in an easterly direction. It also appears that some of this water may be flowing to the southeast where the southern fault is intercepted, from which point the water appears to flow along the fault axis where it exits to the east at exits 1-6.

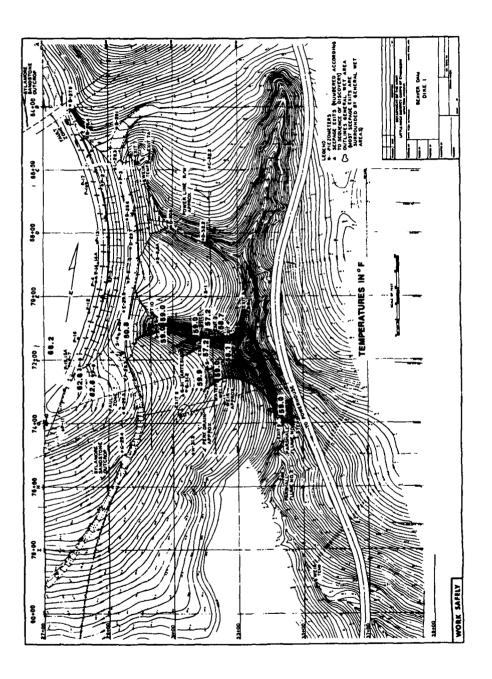
Figure 52. Results of November 1984 downhole water temperature survey

- 68. The results of downhole temperature measurements taken in conjunction with the downhole conductivity surveys are presented in Figures 52 through 54. Figure 52 presents the downhole and seepage exit water temperatures taken in November 1984. As mentioned above, the conductivity/temperature probe was lost in one of the piezometers and thus, measurements were not taken for the northern piezometers or in the reservoir. Temperatures ranged between 57° and 66° F. The temperature measurements taken in the south ravine (seepage exits and piezometers) agree very well with each other. Due to insufficient water temperature readings no seepage paths were inferred for the north ravine area.

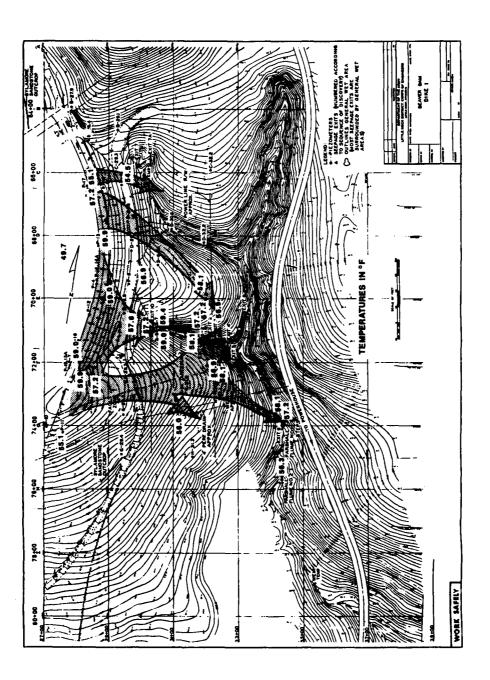
Figure 53. Results of March 1985 downhole water temperature survey

- 69. Figure 53 presents the results obtained from water temperature measurements in March 1985. Water temperatures ranged between 54.5° and 60° F. Seepage paths inferred from the temperature data are shown in Figure 53. The reservoir water temperature was recorded as 49.7° F.

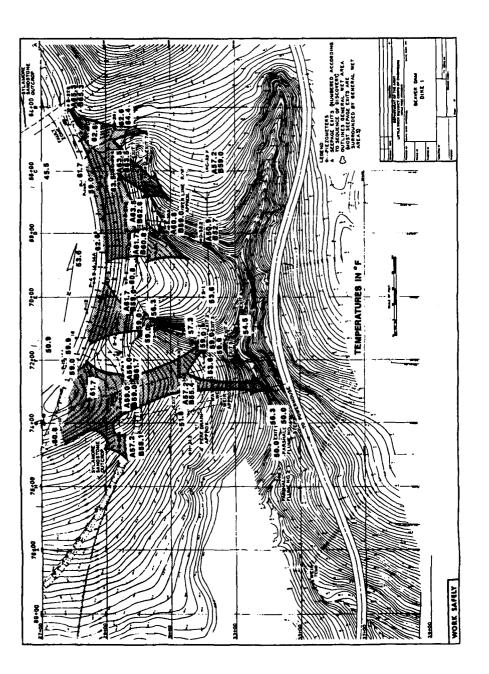
Figure 54. Results of January 1986 downhole water temperature survey

- 70. Figure 54 presents the results obtained from water temperature measurements taken in January 1986. Recorded temperatures ranged between 50 and 65.5°F. A general temperature gradient is evident trending roughly in a northwest-southeast direction. The seepage areas in the south ravine and the piezometers in the southeastern part of the site have the lowest temperatures while the higher temperatures are found in the northwestern part of the site. Temperature measurements were taken at three different reservoir locations as shown. The average reservoir water temperature was 50.0°F. The average temperature for the seepage exits measured was 55.1°F. Using the information gathered from this temperature survey, seepage paths, indicated by arrows, were inferred and are shown in Figure 54.

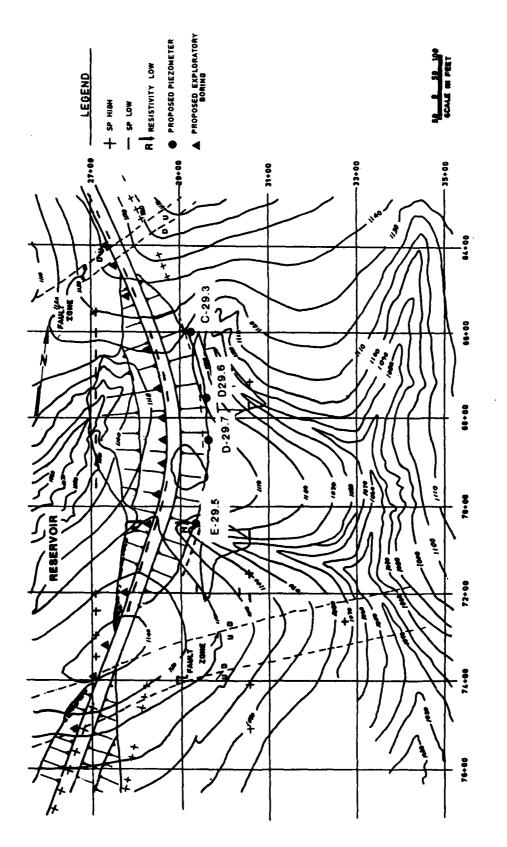
Figure 55. WES-recommended piezometer and exploratory boring locations

on the results of these geophysical tests, seepage paths were inferred and piezometer locations recommended as shown in Figure 55. Piezometers were installed in the locations recommended by WES. A common difficulty in drilling the piezometer borings was heavy loss of drilling (circulation) fluid, with most borings having a total circulation loss at some point during drilling. The boring logs associated with these piezometers indicated excessive water losses and numerous cavities. Piezometer D-29.7 had significant water inflow (est. 5-10 gpm) at a depth of 31.2 ft. A dye tracer test conducted in piezometer D-29.6 indicated a seepage path between the piezometer and seepage Exit 2 located in the south ravine. Piezometer D-29.6 was located in material that was previously thought to be rather competent due to low grout takes during grouting operations in the 1960's, and the inferred seepage path (from D-29.6 to Exit 2) was not previously suspected. A downhole camera lowered into several of the piezometers in August 1985 indicated rock characteristics and features which contribute to subsurface seepage such as open cavities, channels, intensive fracturing, and weathering.

- 72. Twenty-five exploratory borings were drilled along the upstream crest of Dike 1 and its abutments during the period April 1986 to August 1987. The primary purpose of these borings was to delineate the limits and geologic characteristics of the downthrown faulted block of the Boone Formation beneath Dike 1 and the north and south fracture zones that bound the Dike. Originally, the boring locations were selected based on areas that had experienced high grout takes during the previous grouting program. However, locations for the borings were later changed to take advantage of information obtained from geophysical testing. Based on results of the SP, resistivity, and other geophysical testing and also considering previous grout takes, fault locations, and piezometer data, WES submitted a list of proposed locations for exploratory borings to SWL for approval. Figure 56 shows the WES suggested exploratory boring locations.

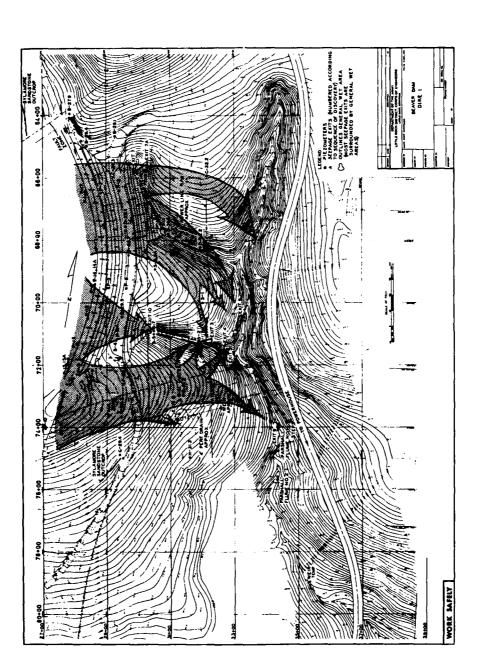
Figure 56. Integrated methods seepage map

75. Based on the results of the tests described above and other pertinent information provided from geologic maps, boring logs, dye tracer tests, piezometers, and seepage flow measurements an integrated seepage map was produced as shown in Figure 56. This map indicates that seepage beneath the dike is flowing primarily in an easterly-southeasterly direction with the greatest amount of water movement occurring between Stations 69+00 and 73+00. The map also indicates the possibility of water movement along the southern fault zone.
